Shear strengthening of masonry panels with GFRP: preliminary experimental results

SHEAR STRENGTHENING OF MASONRY PANELS WITH GFRP: PRELIMINARY EXPERIMENTAL RESULTS

SUMMARY

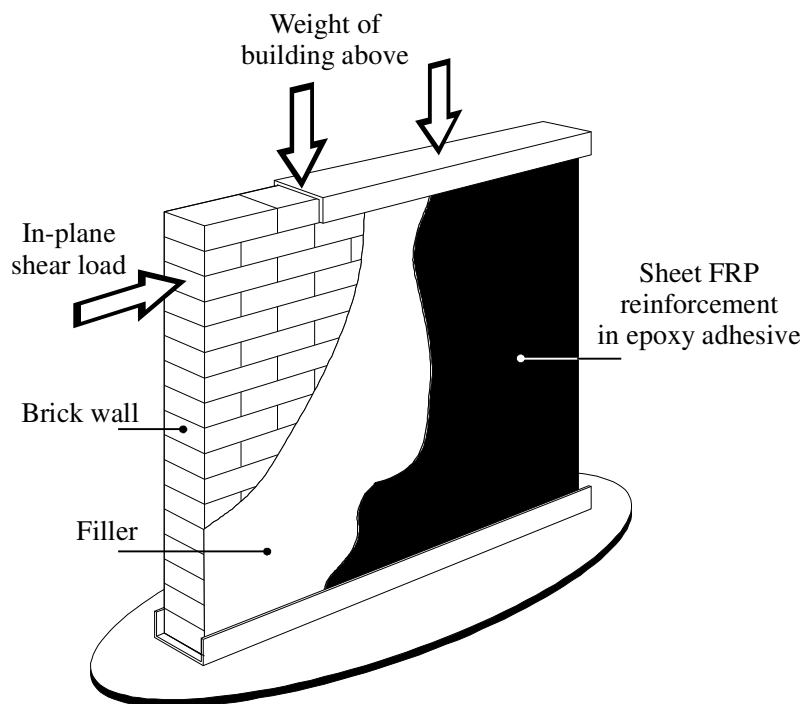
The current work studies the in-plane shear response of masonry reinforced with sheet glass-fibre-reinforced-polymer (GFRP), shown schematically in *figure 1*.

Figure 1 - In-plane shear strengthening using sheet GFRP

A biaxial sheet glass-fibre reinforcement was used, with an equal number of fibres in the 0° and 90° directions. As summarised in *table 1* and indicated in *figure 1*, there were a number of stages to applying the GFRP reinforcement.

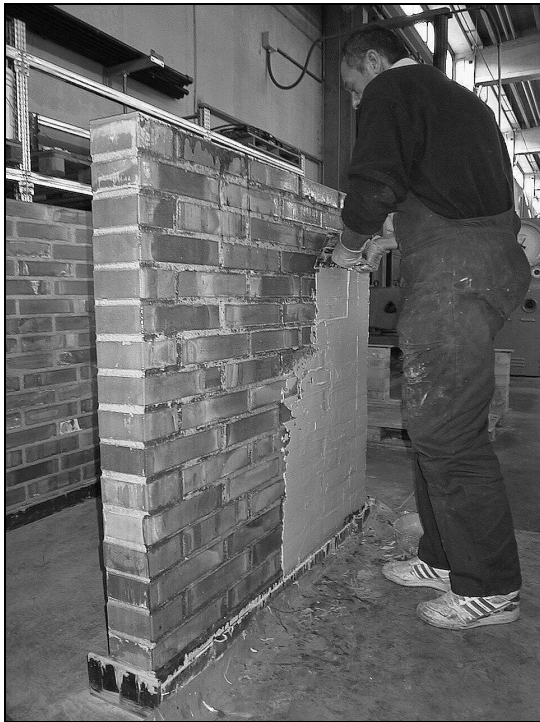
The clay walls were first thoroughly cleaned, and then primed to seal pores in the surface of the bricks and mortar (using an epoxy primer). To provide a smooth surface (and thus good adhesion of the GFRP), an epoxy putty filler layer was applied to the wall (illustrated in *figure 2*). Once this had dried, epoxy adhesive was spread on the wall, the GFRP sheet firmly attached, and the surface of the GFRP coated with a final layer of epoxy resin to ensure saturation of the fibres (shown in *figure 3*). The GFRP was firmly anchored at both the top and bottom of the specimen.

Figure 2 - Application of epoxy filler layer to clay wall

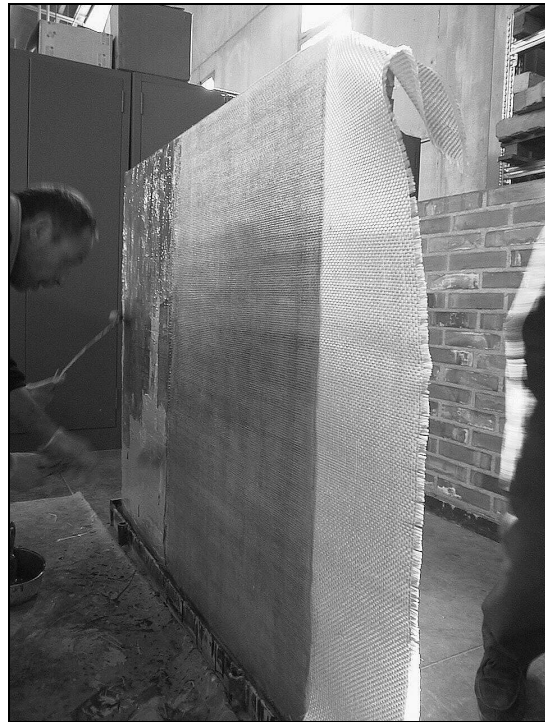
Figure 3 - Wet lay-up of glass-fibre reinforcement in epoxy resin

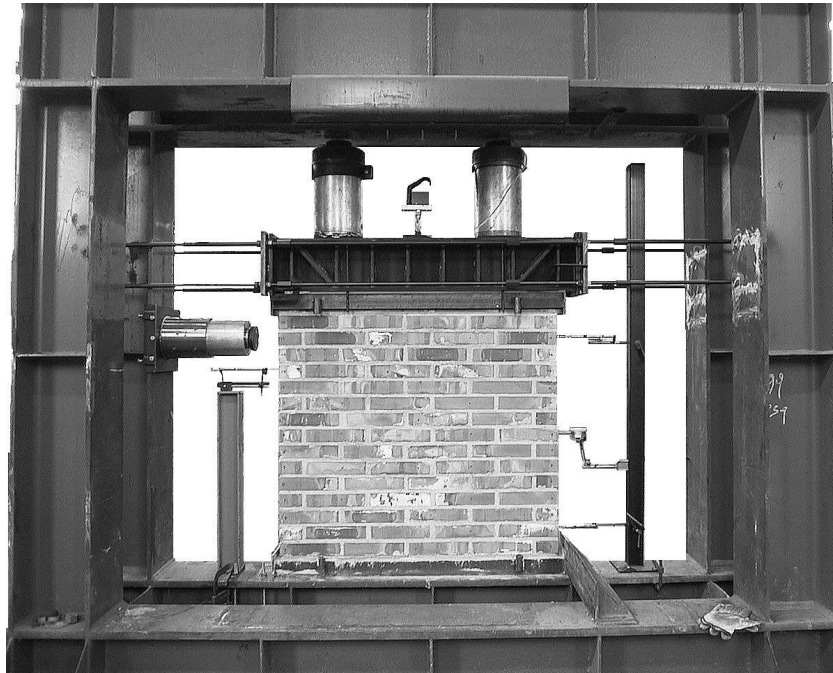
The test arrangement is shown in *figures 4 & 5*.

Figure 4 – Test frame

The vertical prestress load was applied through two connected pistons (V). This load was distributed across the top of the specimen by a stiff steel reaction beam (restrained horizontally by threaded steel bars), and transferred to the wall via a steel cap beam. Two sheets of polytetrafluoroethylene (PTFE) separated the reaction and cap beams, allowing the cap beam to slide horizontally relative to the reaction beam.

Shear load was applied to the wall by a horizontal piston (P). To assess the proportion of this load carried across the PTFE joint by friction, the horizontal force acting on the reaction beam was measured by means of four strain gauges (H).

Figures 4 & 5 also show other instrumentation used in the tests:-

- Four displacement transducers (LVDTs) were used to measure horizontal deflections in the plane of the wall ($\delta_1, \delta_2, \delta_3, \delta_4$).
- Rotation of the reaction beam (assumed equal to the top of the wall) was recorded using an angular transducer (α).
- Strain gauges were applied to the GFRP surface, the position of which depended on the test specimen.

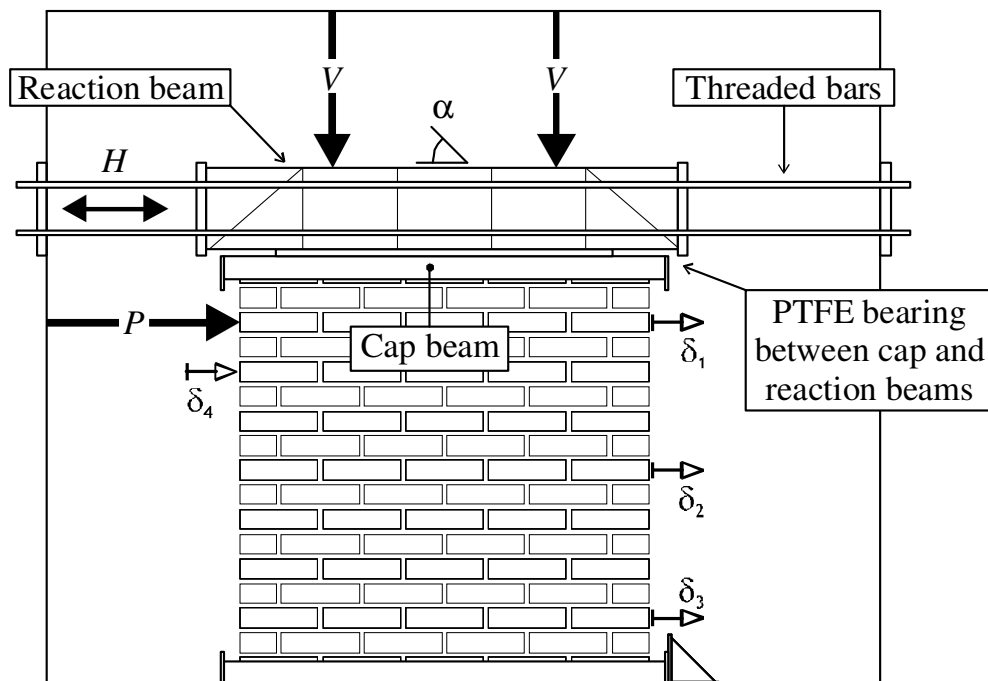
Figure 5 – Test arrangement

The figures plot the load carried through the wall, accounting for the horizontal load carried through the PTFE joint ($P-H$). The horizontal deflection was measured at the same level as the load application point, on the opposite side of the wall (δ_1 in *figure 5*).

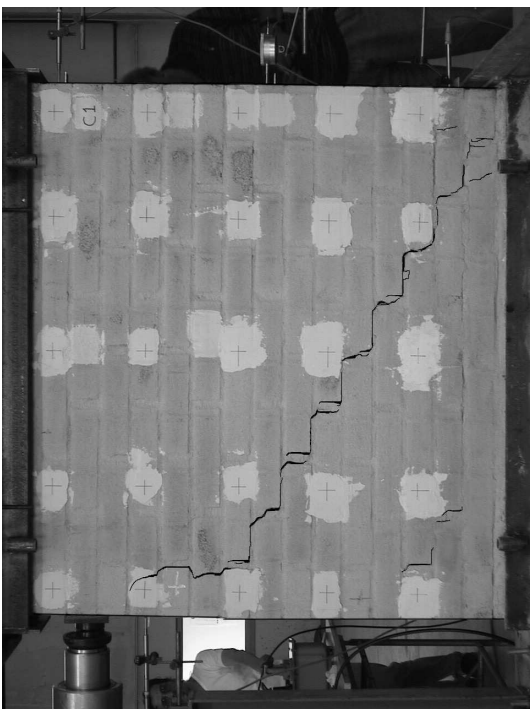
Figures 6 to 9 show the unreinforced clay and concrete walls, and reinforced clay and concrete walls after testing (in that order). The cracks have been highlighted in these figures. (Note that some of the photographs have been mirrored to ensure a consistent view of the loading arrangement).

Except for the unreinforced clay wall, the masonry failed by rapid propagation of a diagonal crack across the specimen. Failure of the unreinforced clay wall occurred along a near-horizontal crack at the base of the wall, and was dominated by sliding along the mortar joint.

Figure 7 – Unreinforced concrete (concrete 1)

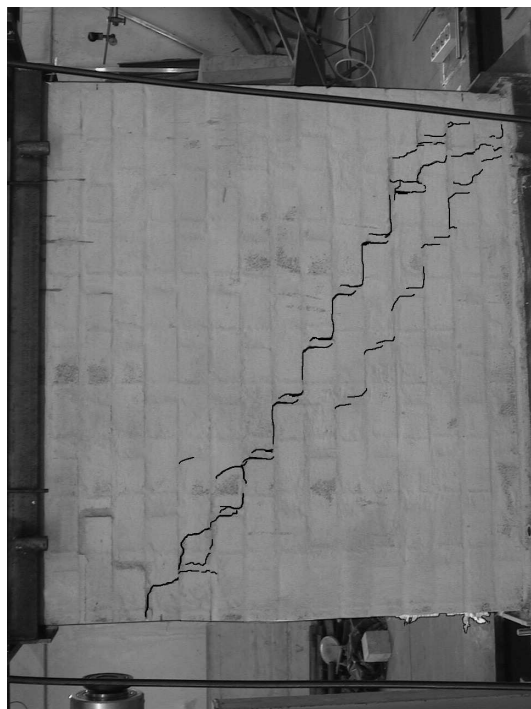
Figure 9 – Reinforced concrete (concrete 3) – mirrored

In the walls strengthened with GFRP, failure was not restricted to a single diagonal crack: the cracking was slightly more distributed, giving a band of cracking.

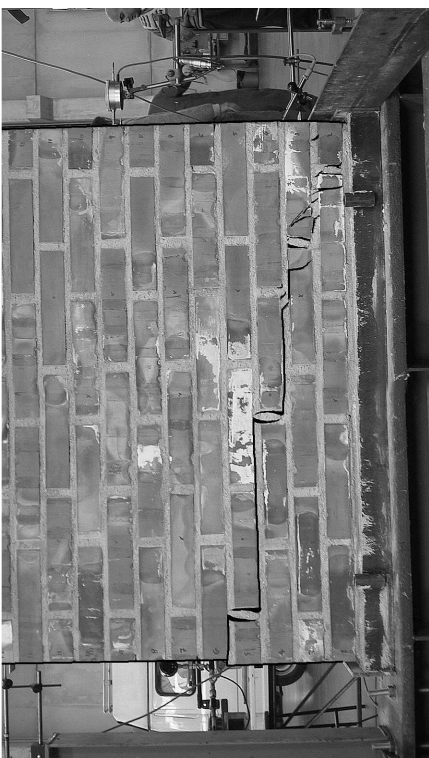
Figure 6 – Unreinforced clay (clay 1)

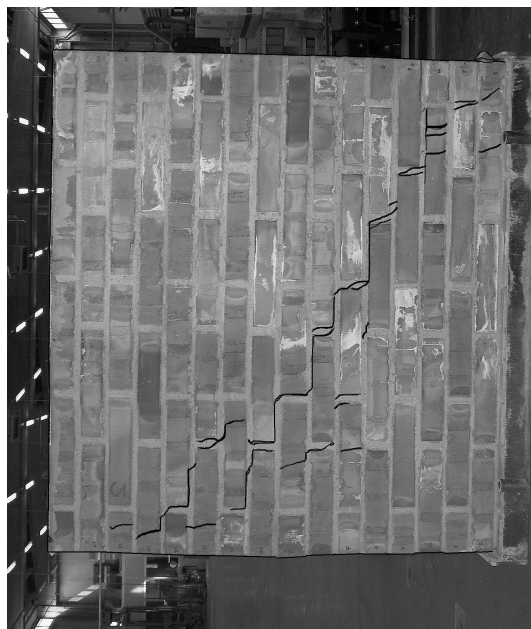
Figure 8 – Reinforced clay (clay 2) – mirrored

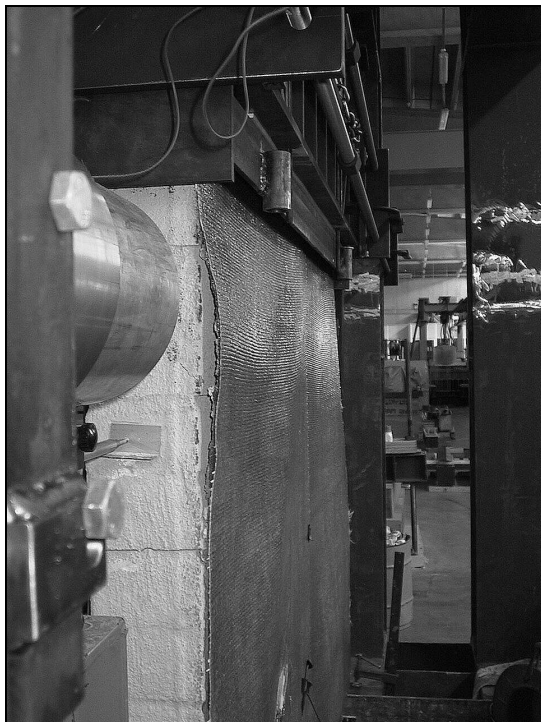
Figures 10 & 11 show the de-bonded reinforcement after a test, while *figure 12* shows the extent of de-bonding. (This was mapped by tapping the surface of the wall and noting where the reinforcement sounded hollow).

Figure 10 – De-bonding at loading point (concrete 2)

Failure of the GFRP strengthening did not occur in the GFRP itself, but was characterised by de-bonding of the reinforcement from the surface of the wall. Initially, small regions of local de-bonding occurred near the load application point and the reaction point at the opposite corner of the wall. At the ultimate load, sudden de-bonding occurred over a large portion of the specimen, roughly along the diagonal from the load application point to the opposite corner.

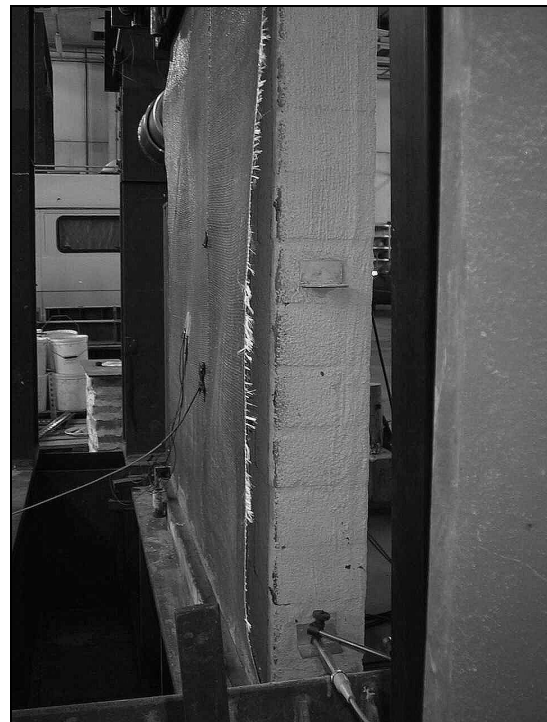
Figure 11 – De-bonding at opposite side to loading point (concrete 2)

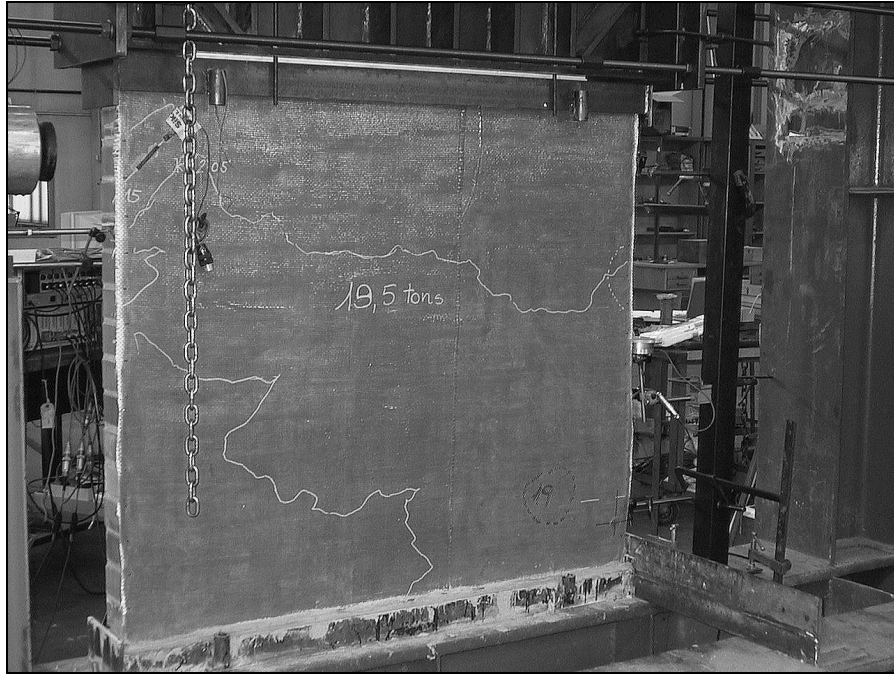
Figure 12 – Extent of de-bonded region (clay 2).

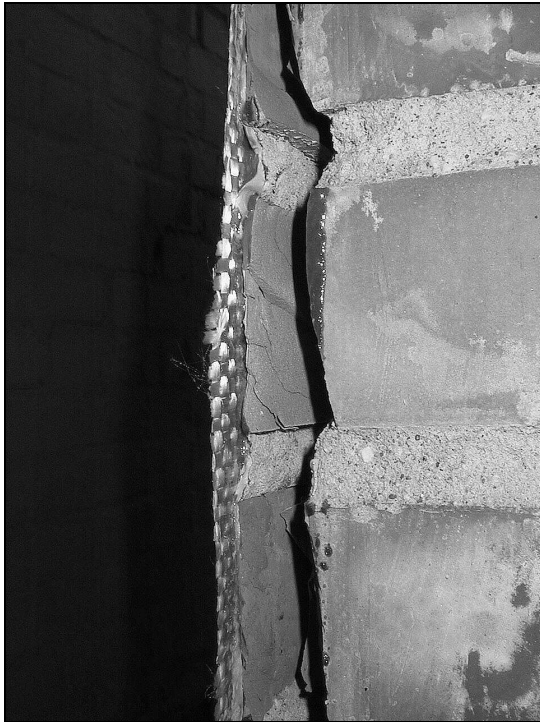
Separation of the GFRP strengthening from the masonry was not due to failure of the epoxy adhesives. In the clay walls, failure occurred beneath the surface of the brick (*Figure 13*). In the concrete walls, failure occurred between the cement render and the bricks (*Figure 14*).

Figure 13 – De-bonding of clay wall

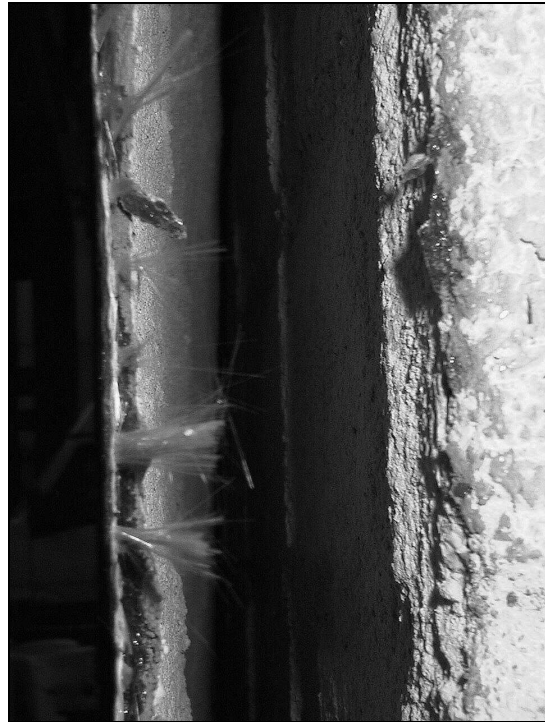
Figure 14 – De-bonding of concrete wall

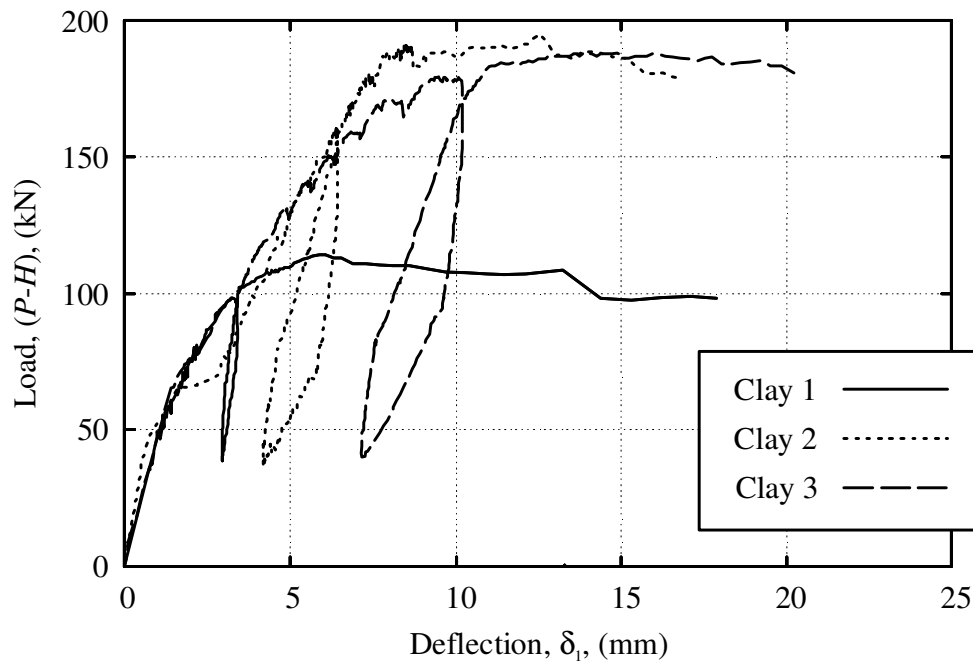
Figure 15 shows the load-deflection responses of the clay specimens, while figure 16 gives the same information for the concrete walls. For clarity, only one unload-reload loop has been shown in the figure for each test.

Figure 15 – Load-deflection response of the clay specimens

Strengthening the clay walls with GFRP increased the ultimate load from approximately 115kN to 190kN. For the concrete walls, the ultimate load increased from 80kN to 110kN (for specimen concrete 2), and 130kN (for specimen concrete 3).

In the present tests (see, in particular, *figure 15*), there is a plateau at the peak load, indicative of ductility. From observations made during the tests, this plateau is due to a transformation in the load-carrying mechanism in the wall. Prior to de-bonding, load is carried by composite action of the masonry and GFRP. After de-bonding, tension cannot be carried across the diagonally-cracked masonry, and a truss mechanism acts, in which the GFRP forms a diagonal tensile member. The load carried by the truss mechanism will depend on the unbonded length of reinforcement. Note that the transformation to a truss mechanism involves de-bonding of the GFRP, and consequently a sudden release of a large amount of energy (which is not desirable).

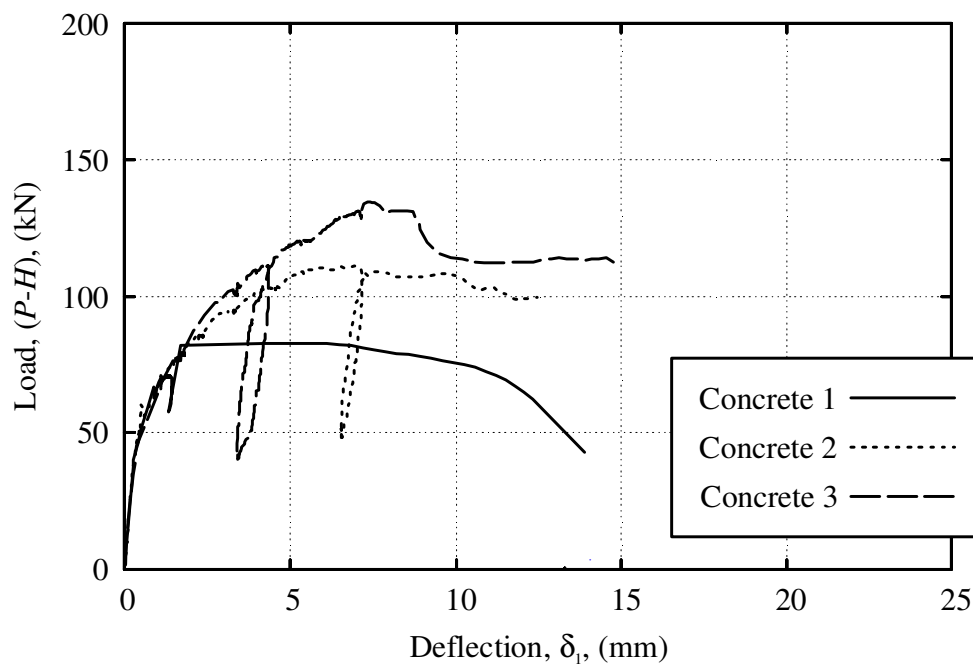
Figure 16 – Load-deflection response of the concrete specimens

The comparatively low failure load of the concrete walls (relative to the clay walls) is probably due to use of an inappropriate mortar. The concrete bricks were very porous, and consequently the mortar dried before it had fully cured.

Applying GFRP with balanced $0^\circ / 90^\circ$ fibres is an effective method of increasing the ultimate strength of masonry. For both clay specimens, and specimen concrete 3 an increase in the ultimate load of approximately 65% was observed. However, for specimen concrete 2, the increase in ultimate load was only 38%.
